**Re: HPA APP ID #14829**

**Fish Ladder Monitoring Report for November 30<sup>th</sup> through December 6<sup>th</sup>, 2020**

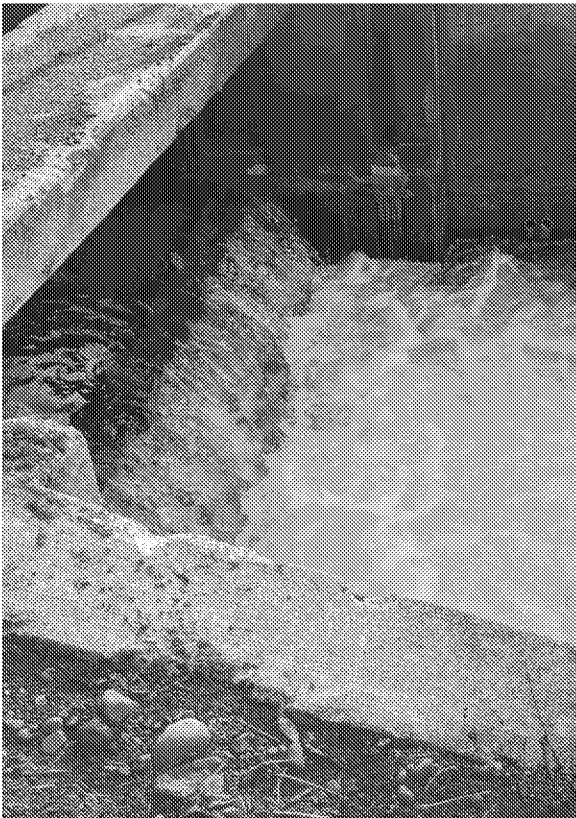
For the week of November 30<sup>th</sup>, the ladder was observed on December 3<sup>rd</sup> from 11:20 – 12:25. The river conditions and fish ladder were monitored from the ladder side (east bank) of the river. River discharge on Dec 3<sup>rd</sup> was approximately 325 cfs during the time of observation, with a maximum of 345 and minimum of 315 cfs for the day. The weekly high total river discharge reached 475 cfs, and the weekly low reached 305 cfs. At the ladder, a staff gage placed at the edge of a weir wall measured a water column height of 0.7 ft. Weather conditions were mostly overcast, with no rain at the time of observation. Ambient air temperature was 5.4°C. The drop height from the last ladder cell to the raceway appears to be at the 12” or greater mark, and an adjustment of the cell drop height may be necessary soon.

Photo 1: Ladder outflow on December 3<sup>rd</sup>.

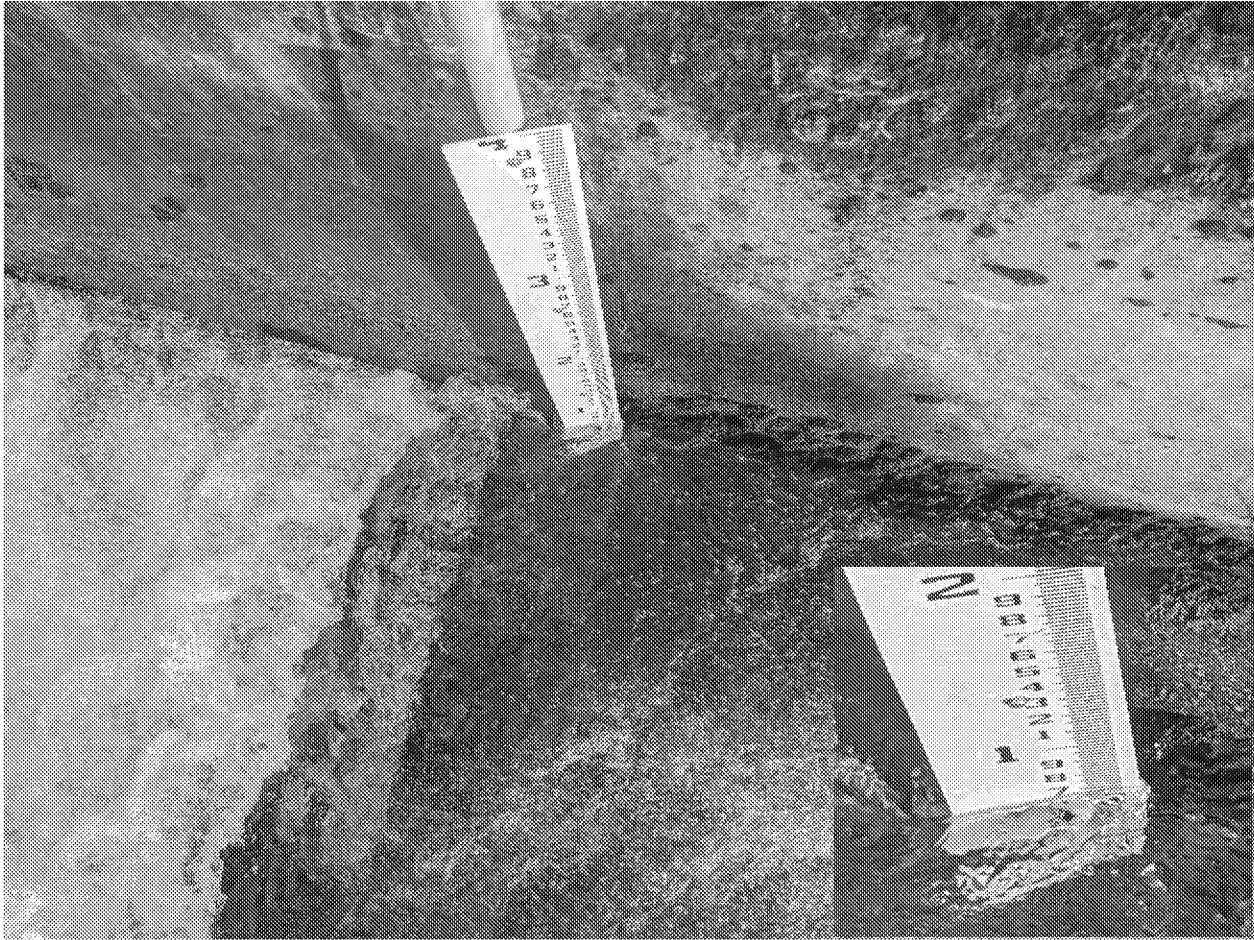
Photo 2: Staff gage measurement on top weir wall edge.
